Burda WC-control T690 Flush triggering by radio or manually with preset interval flush

Avoidance of stagnant water, which can lead to legionella contamination

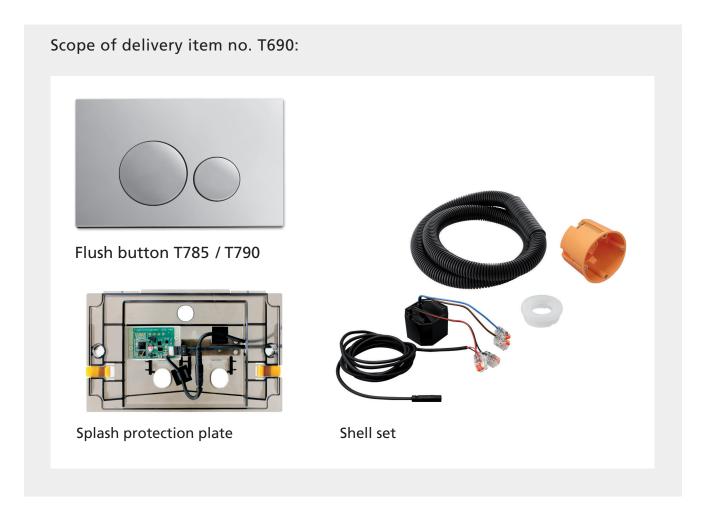
- Preset interval flush (1 x per 24 hours)
 Can be changed via app for Android 1-148 hours
- Flush duration (factory setting 7 sec. can be changed via app for Android)
- Test rinse (can be triggered via app for Android)
- Standard triggering manual or automatic hygiene flush
- Radio release via support folding handles (2 radio transmitters can be connected)
- Flush Settings-App for Android can be requested from service@burda-online.com

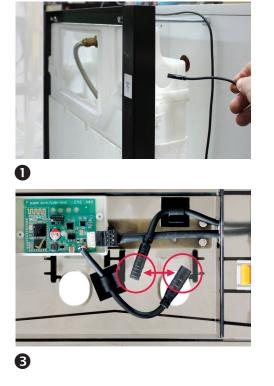
Mounting the splash protection plate

- 1. Place flush-mounted box for power supply unit (note: note cable length, supplied cable length: 3 m)
- 2. Remove the existing splash guard plate
- 3. Remove one of the cistern plugs at a suitable point and replace with a new one with a hole

- 4. Connect the black empty conduit (protective conduit) to the cistern and flush-mounted box for the power supply unit
- 5. Insert the cable into the empty conduit (protective conduit) so that the Rapp plug (black plug) can be fed through the cistern

- 6. Guide the Rapp plug (black plug) through the right-hand side of the new splash guard and secure with the free cable clamp
- 7. Install new splash guard plate

- 8. Connect the Rapp plugs in front of the splash protection plate
- 9. Push the power supply unit into the flush-mounted box and, if necessary, connect it to the low-voltage side (DC, already connected at the factory) and to the 230 V domestic power supply (AC~).
